Assessment of Potential Barriers to Fish Passage in North Clackamas Watershed Council Area Streams

North Clackamas Watersheds Council
Contact: Amy van Riessen, amy@ncwatersheds.org

Altap Restoration LLC
Contact: Todd Alsbury, talsbury9921@msn.com

March 2023

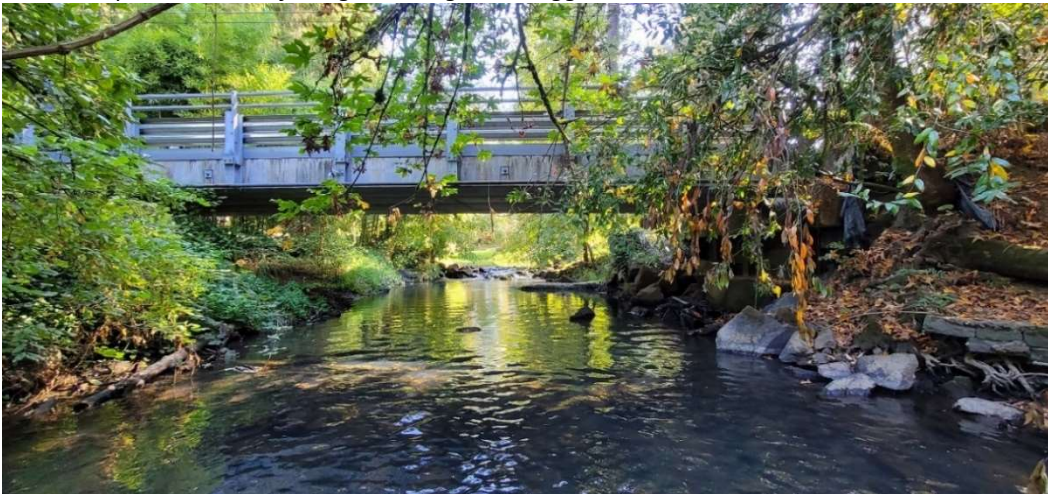
The Kuehn Road crossing of Kellogg Creek is a bridge that fully spans the bed and banks of Kellogg Creek. The bridge abutment on the left bank (to the right on the photo) is at the channel margin and could be at risk of being undermined due to the channel thalweg being present along the toe of the abutment. Angular rock is protecting the abutment but can be seen downstream in the middle of the channel indicating movement at some flows. The Kuehn Road Bridge is documented on the ODFW Statewide Barrier Database, but it does not describe it as a barrier to any fish life stage or species. All life stages of native migratory fish can pass upstream and downstream at all fish passage flows¹.

Photo 1. Upstream view of bridge crossing on Kellogg Creek at Kuehn Road

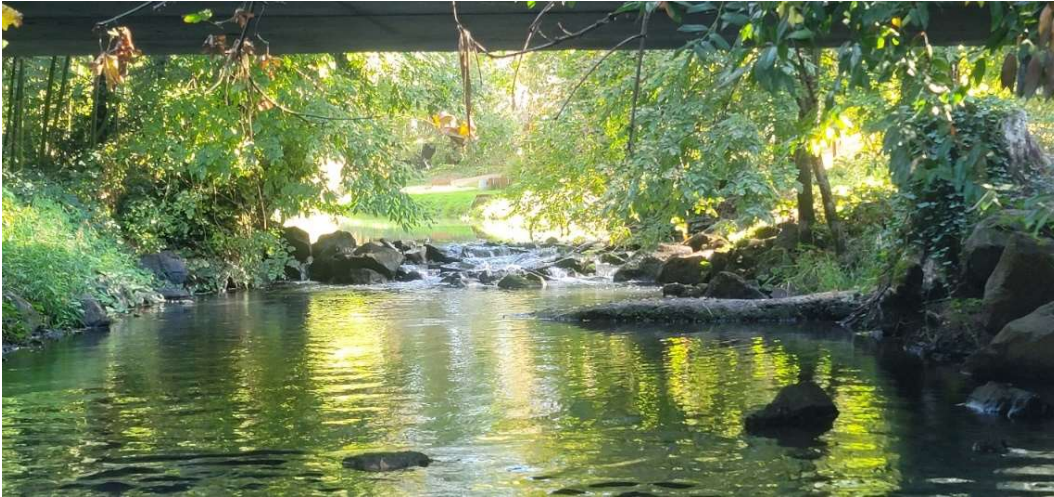
The rock weir located upstream of Kuehn Road is a structural component of a pipeline crossing beneath Kellogg Creek. The rock weir protects the pipeline from being damaged by or undermined by natural stream processes. The rocks used for pipeline protection are 2-3' diameter angular basalt.

It is likely that all life stages of native migratory fish can pass upstream past this weir but there may be times when upstream passage is limited by exceptionally low flows. Adult coho migrating upstream in fall months may be challenged to pass this structure at low flows due to lack of jump pool and flat angular rock that limits their ability to successfully swim over the rock structure. The weir is not documented on the ODFW barrier database.

Photo 2. Rock weir upstream of Kuehn Road

Structural improvements could be made to the rock weir which would facilitate passage at low flows. These include creation of a jump pool downstream of the weir which would allow adult migratory fish to gain the speed they need to make jumps over structures such as the rock weir. In combination with creation of a jump pool, a low flow channel could be developed to confine flows to a single channel that would be deeper and allow adults to utilize their caudal fins to swim over structures.

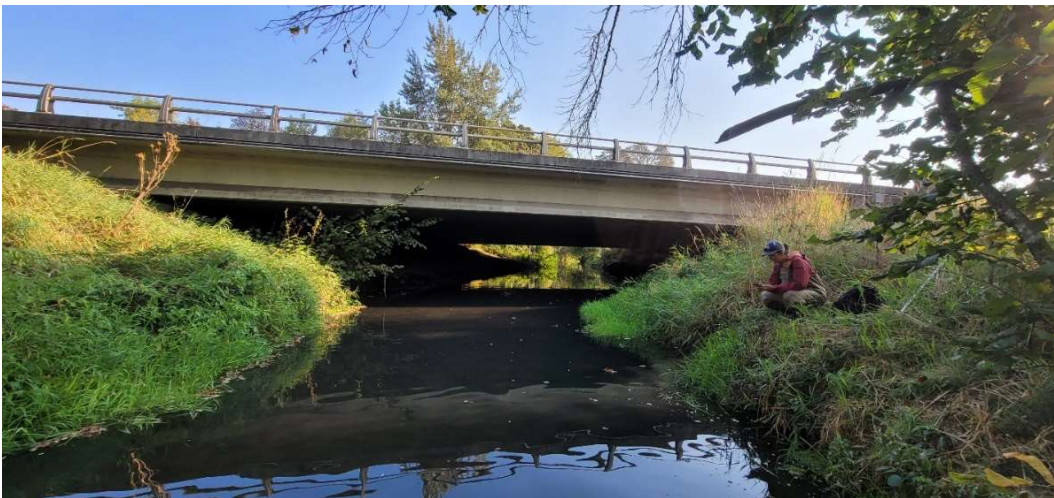
The Highway 224 crossing of Mt. Scott Creek is a bridge structure that fully spans the active channel of Mt. Scott Creek. Natural streambed substrate is present throughout the length of the crossing and there are no structure bridge component impeding flow.

All life stages of native migratory fish would not be impeded as they migrate upstream or downstream past this structure.

Photo 3. Upstream view of the Highway 224 crossing of Mt. Scott Creek. Bridge fully spans natural stream channel below.

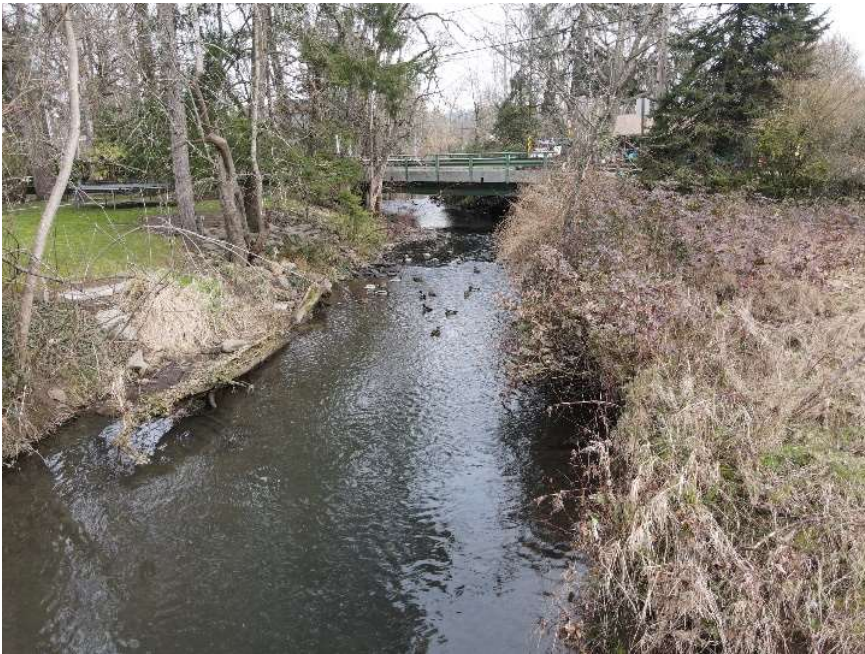
The Rusk Road crossing of Mt. Scott Creek is a bridge structure that is narrower than the natural active stream channel. Abutments on both sides of the stream channel are in direct contact with water at low flows. There does not appear to be any erosion or undermining of the abutments but there is minor damage to wingwalls on the downstream end of the left bank abutment.

Despite stream flows being slightly impeded by abutments on both side of the stream there does not appear to be any passage limitation due to the presence of natural streambed material and relative short length of the crossing over the stream.

Photo 4. Rusk Road bridge crossing of Mt. Scott Creek. View looking upstream at full spanning bridge. Bridge abutments slightly impede flows as they are near the active channel width. Coarse bed material is present through the structure.

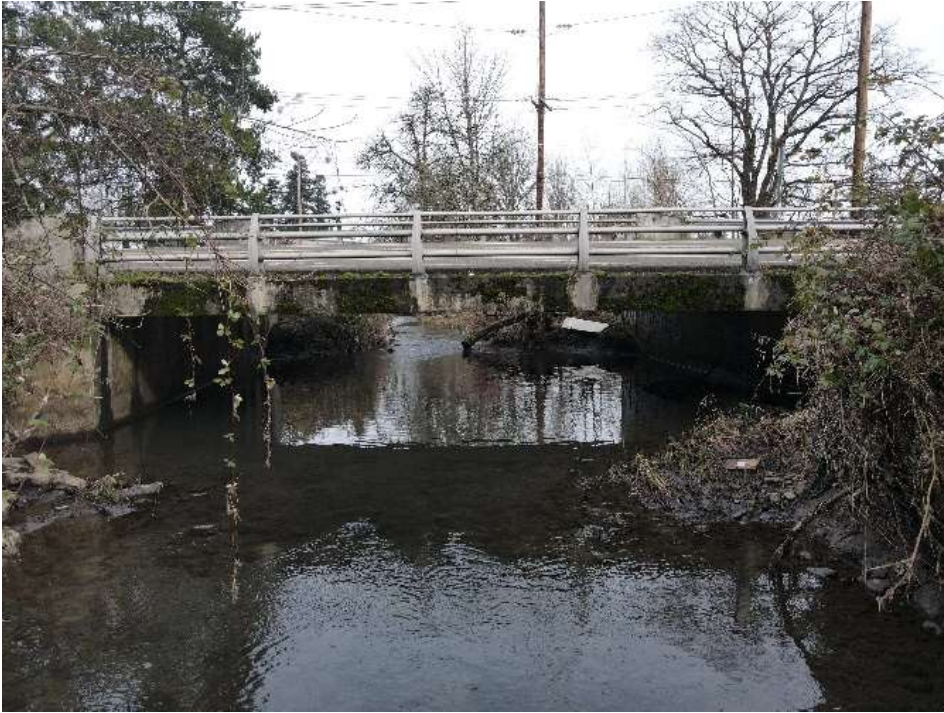
The SE Lake Road crossing of Mt. Scott Creek is a bridge structure that does not fully span the creek channel and does impede stream flow as evidenced by deposition and scour patterns upstream and downstream of the structure. The low head height of the bridge can create challenges for larger trees or debris from passing through and providing for instream habitat structure, if they are mechanically removed by local road departments.

There does not appear to be any significant impediment to upstream passage of fish but the structure should be monitored to assess annual deposition wood and sediment that may be impacting the crossing by reducing cross sectional area beneath the structure. If wood is present in the channel that is impacting the crossing all efforts should be made to maintain the wood in the channel downstream of the structure.

Photo 5. View looking upstream at the SE Lake Road crossing of Mt. Scott Creek. Bridge abutments are within active channel, but they appear to have limited potential to impact upstream migration.

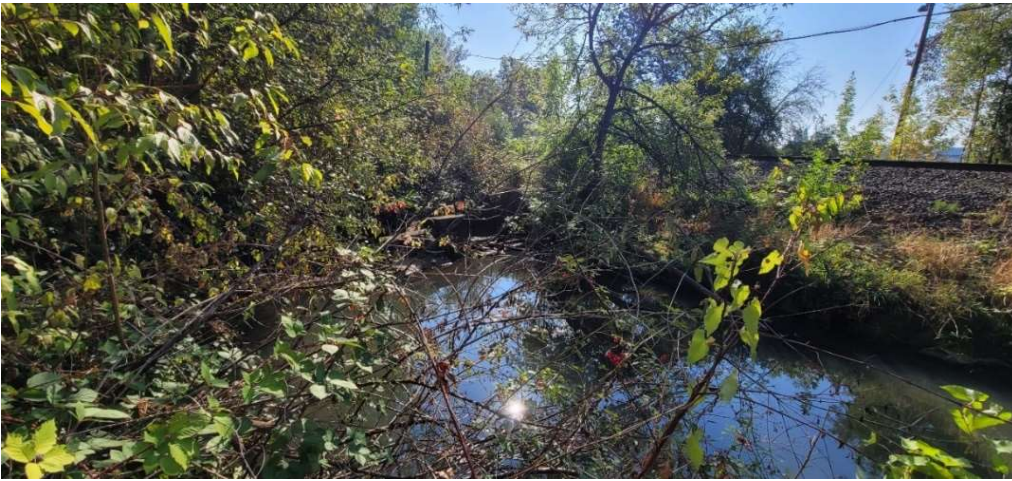
A failing concrete water control structure (weir) located near the downstream end of the 3-Creeks Natural Area impedes flow and natural movement of streambed material in Mt. Scott Creek. Ownership or original intent of the weir is not known at this time. The weir combined with a railroad crossing less than 100 feet downstream may create a flow dependent barrier to upstream passage of adult and juvenile fish. The railroad crossing is narrower than the stream is wide at this location and the weir creates an unnatural jump and potential velocity barrier due to partial failure of the weir on the left bank.

Photo 6. View looking upstream at concrete water control structure.

The failing concrete weir in lower section of 3-Creeks and the water control structure at 3-Creeks are both need further assessment to determine the extent to which they may be impacting upstream passage or stream habitat (in the case of the failing weir). An assessment of instream and riparian habitat completed by ODFW (ODFW 2008) and the council (NCWC, 2020) documented some of the highest quality habitat for both spawning and rearing juvenile fish in the entire watershed in 3-Creeks. It is important to ensure that passage is not restricted at any time of year so fish can reach spawning areas (identified in lower Phillips Creek and Mt. Scott reach downstream of Phillips) and juveniles can reach potential cold-water refuges in the summer in tributary streams feeding into the 3-Creeks Natural Area (i.e., Phillips and Dean creeks) (NCWC, 2023).

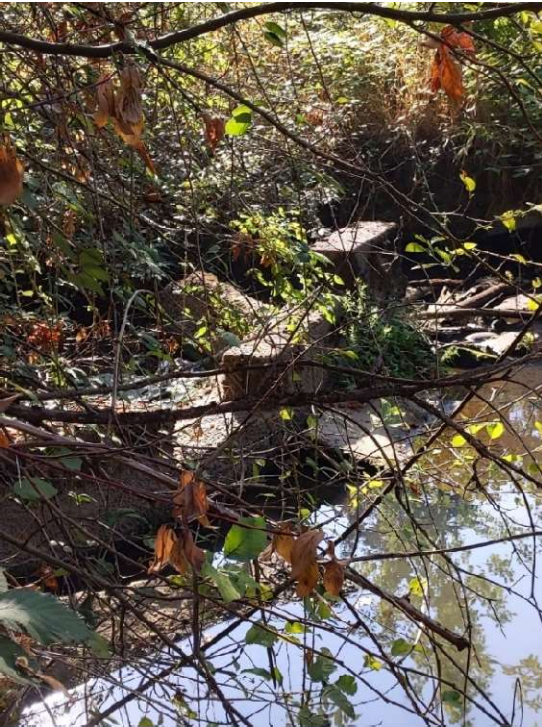
Photo 7. Water control structure. Notice damage to structure at far bank. The left bank is eroding at an unnatural rate because of the failing structure. It is not clear the purpose of the structure or who built it.

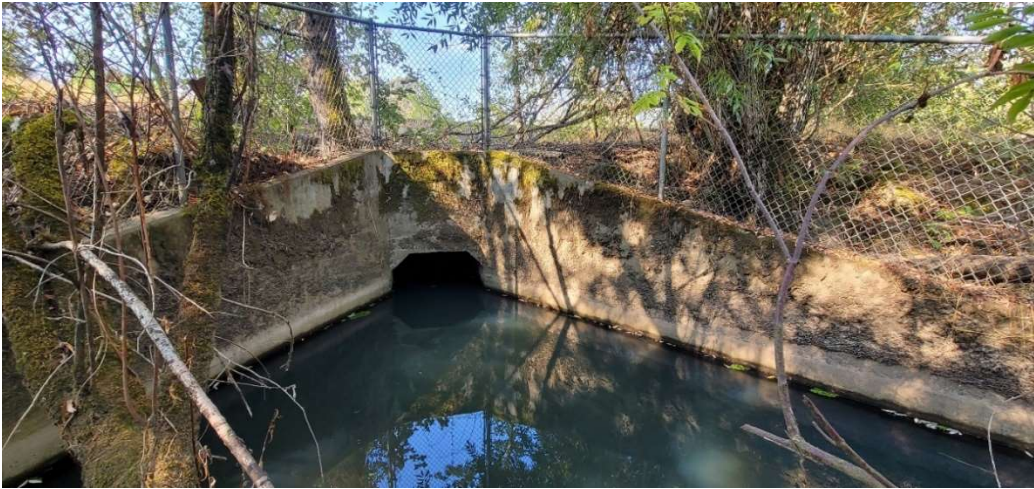
A concrete dam/water control structure is present within the 3-Creeks Natural Area which is used to control flooding downstream in the City of Milwaukee and surrounding area. The structure consists of a constant flow bypass (Photo 8) and three gates (Photo 9) that are operated to control the amount of flow allowed to bypass the structure. A pool downstream of the structure controls the water level and to some extent flows through the culvert but it is unclear whether the velocity of water through the structure is too high when flows in Mt. Scott are also high and the culvert is at capacity.

Photo 8. Concrete culvert bypass at 3-Creeks

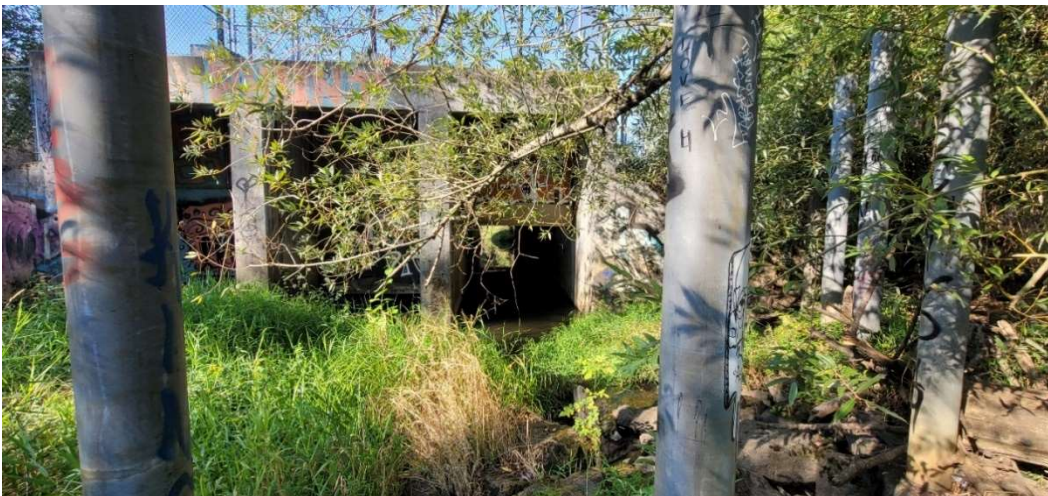
The flow control gates are operated during flood events to control the amount of flows and corresponding flooding in lower reaches of Mt. Scott Creek downstream of 3-Creeks. Further analysis is necessary to determine if either the gates or bypass pipe create any impediment to upstream passage. It does not appear that downstream passage is impacted by the dam or control gates as is the case with other dam structures.

Photo 9. Three control structure gates at 3-Creeks

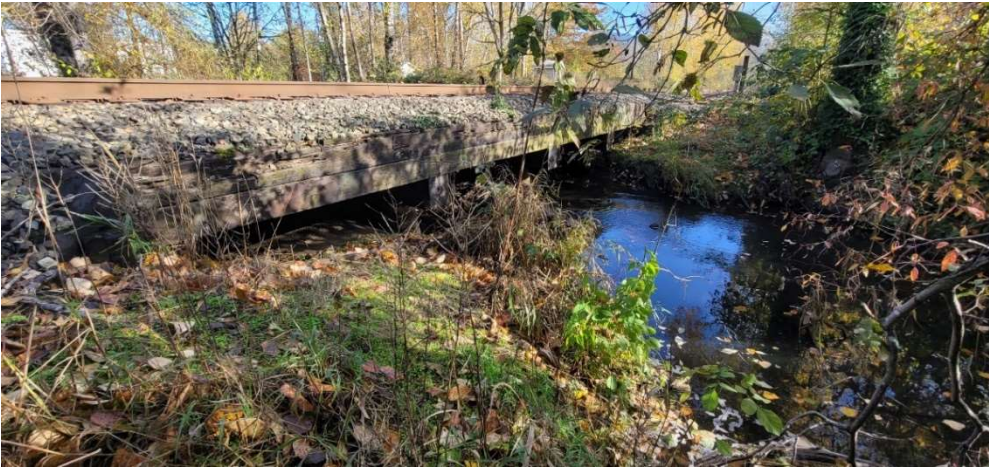
A railroad crossing at the upstream end of the 3-Creeks Natural Area is a low height crossing that likely impedes natural movement of woody material in the stream. Wood removal is evident in the area as is typically the case with crossings that have limited height to allow movement of materials that might be coming downstream. There does not appear to be any passage limitation, but excessive loading of material could create higher velocity flow through this narrow crossing.

Photo 10. Railroad crossing at upstream end of 3-Creeks Natural Area

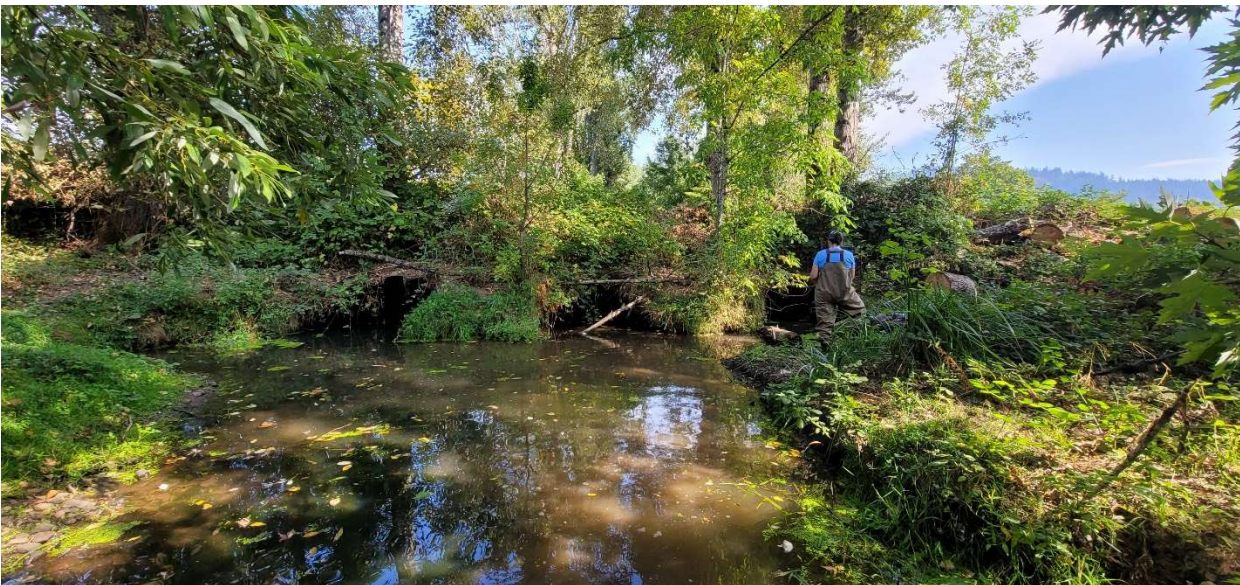
The SE 84th Avenue crossing of Mt. Scott Creek is a three-barrel culvert that conveys flows beneath SE 84th Avenue. The combined culvert widths are less than the active channel width of the stream and two of the culverts are partially filled with streambed sediments reducing cross sectional area. Filling of the culverts with streambed material reduces their cross-sectional area and forces most of the stream flow through one of the three culverts. High stream flows typical of fall and winter migration periods may partially restrict passage of adult spawners and rearing juvenile fish.

Photo 11. SE 84th Avenue crossing of Mt. Scott Creek (between Costco and OSP Crime Lab)

- 3) Mt. Scott Creek at SE 84th Ave.
 - The crossing of Mt. Scott Creek at SE 84th Ave. is likely a partial barrier to upstream passage at higher stream flows. Two of the three culverts are partially filled with sediment which forces most of the stream flow down one culvert. This condition may lead to a temporal (flow dependent) barrier to upstream migration. The crossing is downstream of the I-205 culvert which was retrofit to provide passage up to moderately high-quality habitat upstream along Mt. Talbert.

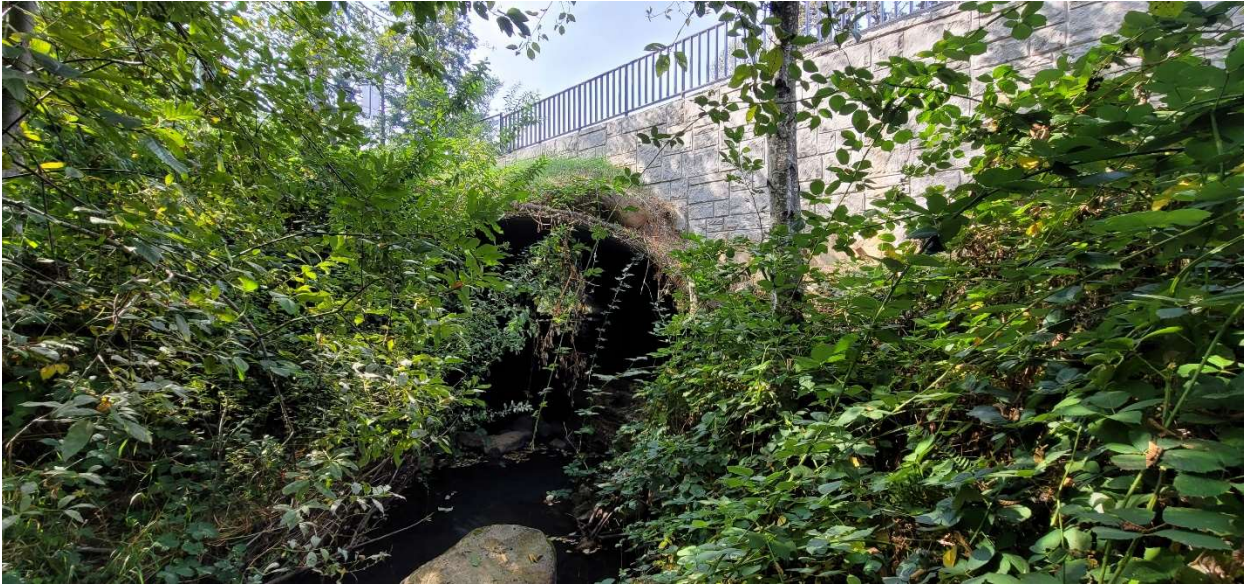
The I-205 crossing of Mt. Scott Creek is a 408-foot-long x 15-foot-wide round culvert that conveys water beneath I-205. The original construction of the I-205 culvert did not include baffles which resulted in a culvert with flows that likely

exceeded the abilities of most migratory fish. The long length of the culvert combined with lack of resting spots for upstream migrating fish created a barrier that few fish were effectively able to pass. Baffles (Photo 13) were installed in the culvert in 2003 that slowed flows through the culvert and created pools that allow fish to rest and jump over the 6" height differential between weirs. It does not appear that fish passage is restricted through this crossing due to installation and effective operation of the weirs.

Photo 12. *Upstream view of the Mt. Scott Creek crossing beneath I-205.*

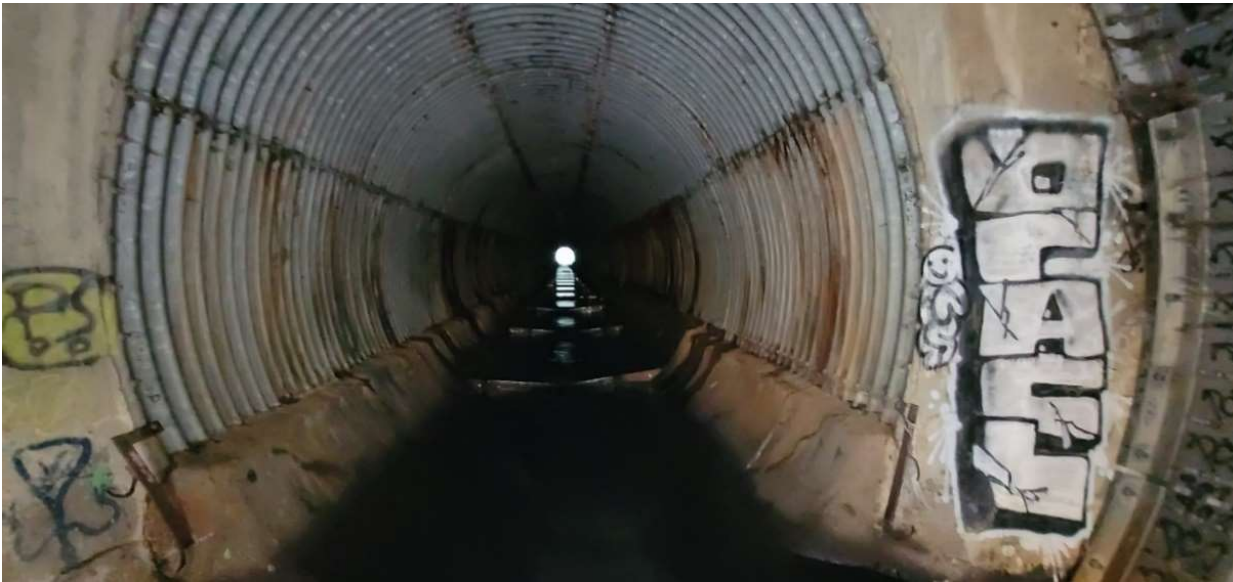
Photo 13. *I-205 culvert showing baffles installed to improve upstream passage (upstream view)*

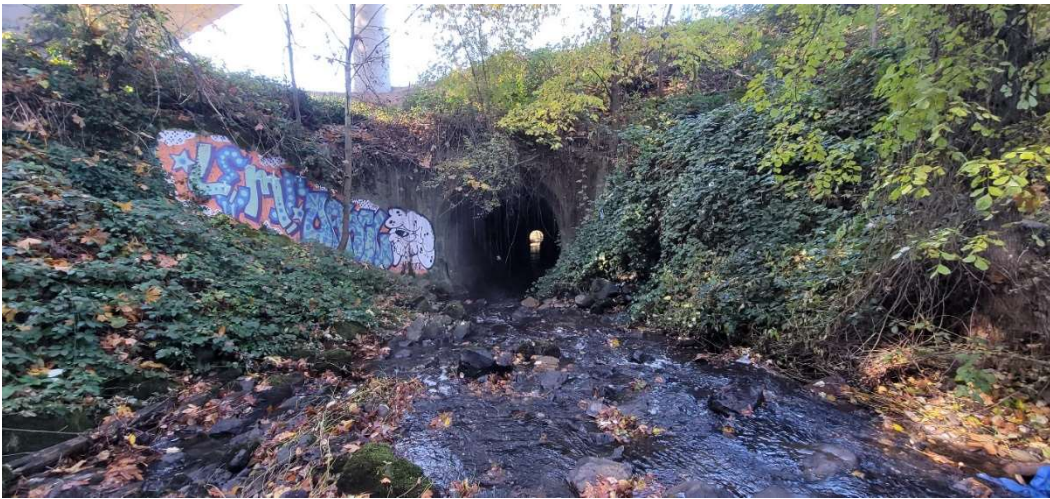
Photo 14. View downstream into the I-205 crossing of Mt. Scott Creek.

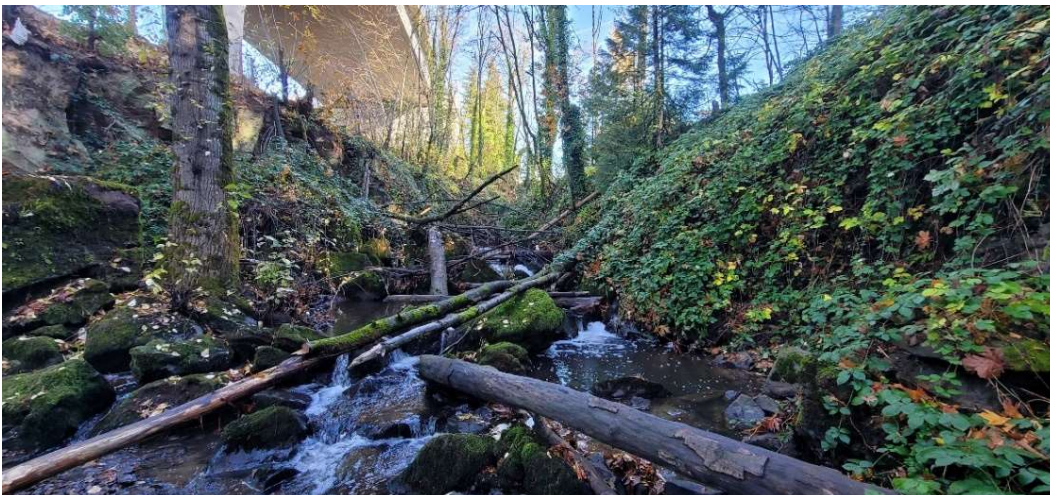
A boulder cascade and bedrock drop directly upstream of the I-205 culvert and beneath the Sunnybrook Blvd connector fly-over bridge creates a partial barrier to upstream passage due to multiple elevation drops over angular rock. The boulder cascade combined with bedrock drop directly upstream create a partial barrier to upstream passage. It is likely a flow dependent barrier that restricts upstream passage at high and low stream flows.

Photo 15. Upstream view of boulder cascade directly upstream of I-205 culvert.

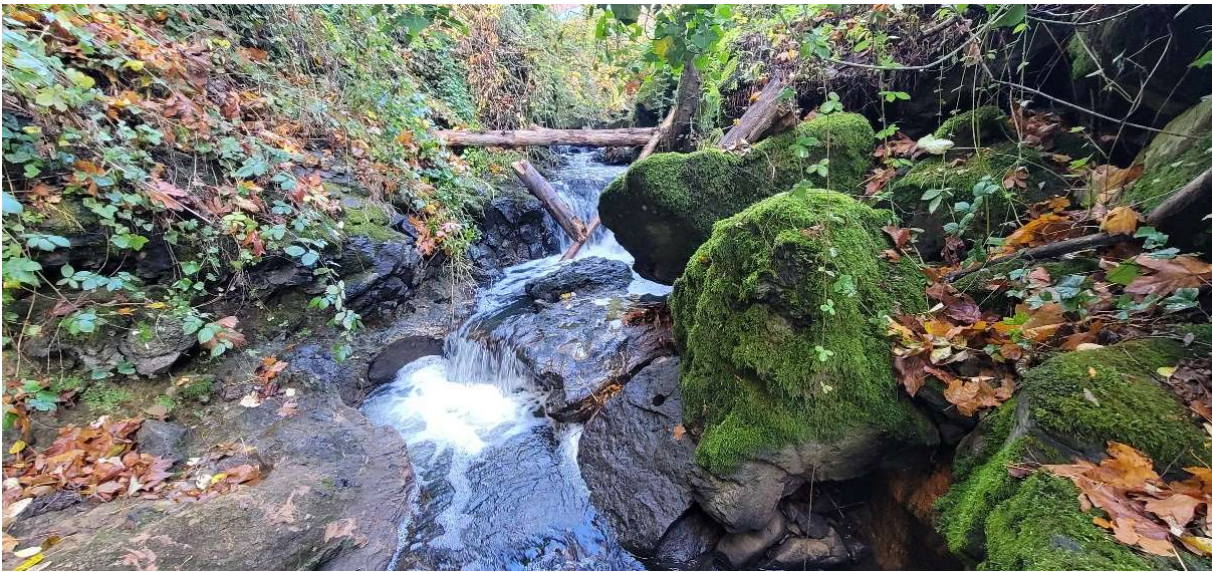
Photo 16. Upstream view of bedrock drop directly upstream of I-205 culvert.

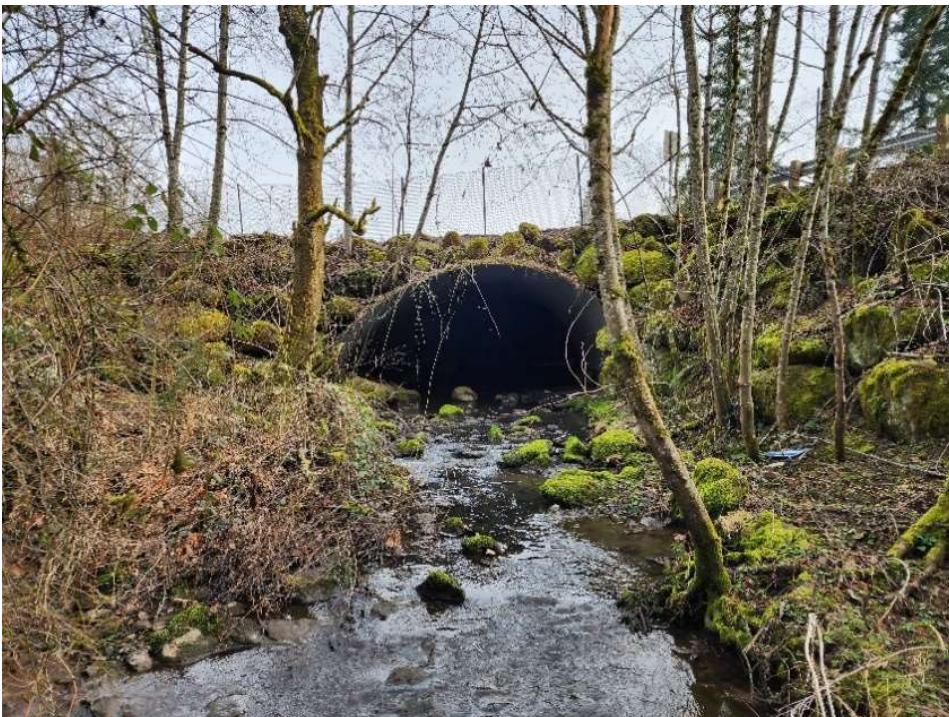
The 129th Avenue crossing of Mt. Scott Creek is an arched culvert that spans the active channel of the stream in this area. The culvert takes a 30° turn in the middle in an apparent effort to maintain sinuosity through the structure. A large diameter tree is situated in the upstream end of the culvert which restricts flow and forces stream energy to the left bank through the structure. There does not appear to be any restriction to upstream or downstream passage through this crossing.

Photo 17. Upstream view of the SE 129th Ave. culvert on Mt. Scott Creek

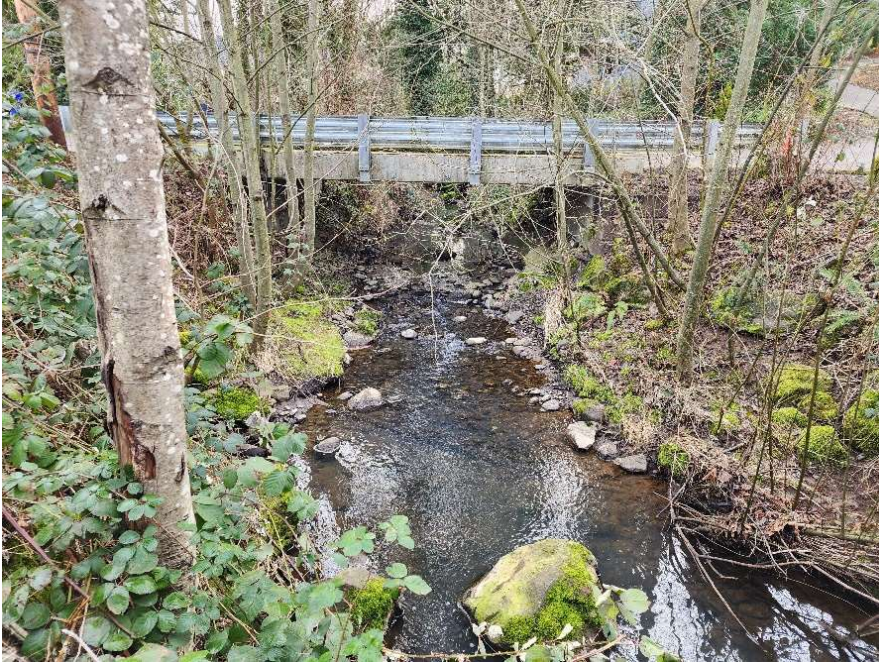
The crossing of Mt. Scott Creek directly upstream of SE 129th Ave. is a small, single lane bridge that provides emergency access to the neighborhood off SE Snowfire Ct. The bridge abutments are near the active channel, but they do not impede flows or create unnatural erosion near the crossing. Bedrock is evident in the stream under and upstream of the crossing, but it does not appear to be associated with the bridge or abutments. The crossing is near the upstream end of anadromous fish use in Mt. Scott Creek and does not impede passage.

Photo 18. Upstream view of bridge crossing directly upstream of SE 129th Ave. on Mt. Scott Creek.

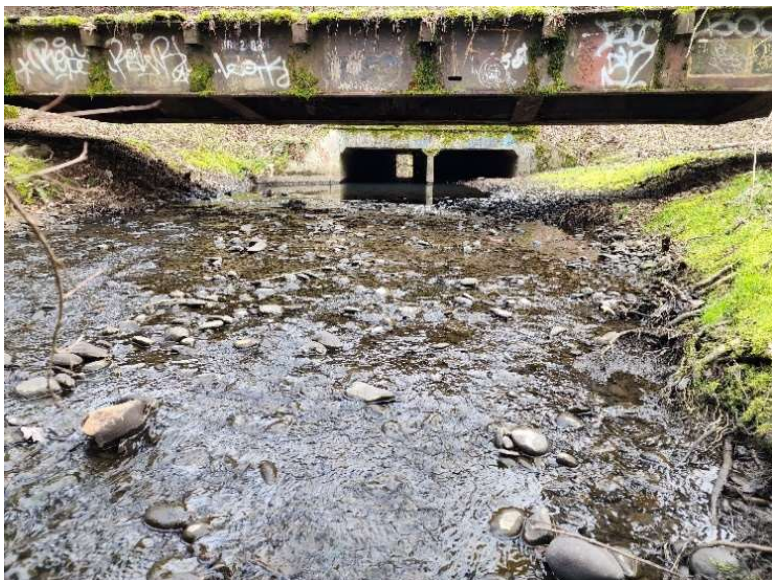
The Phillips Creek crossing under SE 82nd Ave. consists of two 4-sided concrete box culverts. The culvert to the right in the photo is constricted due to sediment build-up that reduces cross sectional area ~50%. This causes most of the flow in Phillips Creek to be conveyed through the culvert to the left. Fish passage may be restricted at higher stream flows due to most flows being conveyed through one culvert, leading to higher velocity flow that may restrict certain life stages or species of fish (i.e., juvenile salmonids, adult chum salmon).

Photo 19. Upstream view of the SE 82nd Ave. crossing of Phillips Creek. Abandoned railcar bridge that was a trail over Phillips and Mt. Scott creeks is seen in foreground.

- 4) Phillips Creek at SE 82nd Ave.
 - The twin concrete box culverts in the lower reach of Phillips Creek may restrict access to higher quality habitat upstream when stream flow is higher than normal in fall and winter months. High road fill and culvert length would lead to a very expensive project to replace the culverts. Consideration should be given to a potential retrofit if an analysis of culvert hydraulics indicates that passage is restricted. The crossing immediately upstream (SE 84th) is also a partial barrier.

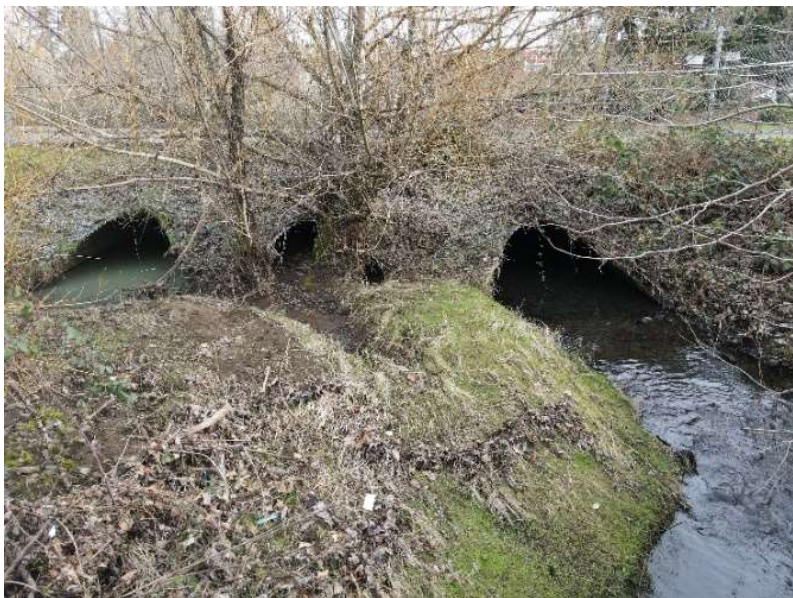
The SE 84th Ave. crossing of Phillips Creek consists of three corrugated metal pipes (CMP's). Two of the three culverts are partially filled with sediment leading to the culvert to the right in the photo below conveying most of the stream flow in Phillips Creek. High stream flows typical of winter months may restrict upstream access due to the high velocity water being conveyed through one of three pipes.

Photo 20. Upstream view of the SE 82ND Ave. culverts

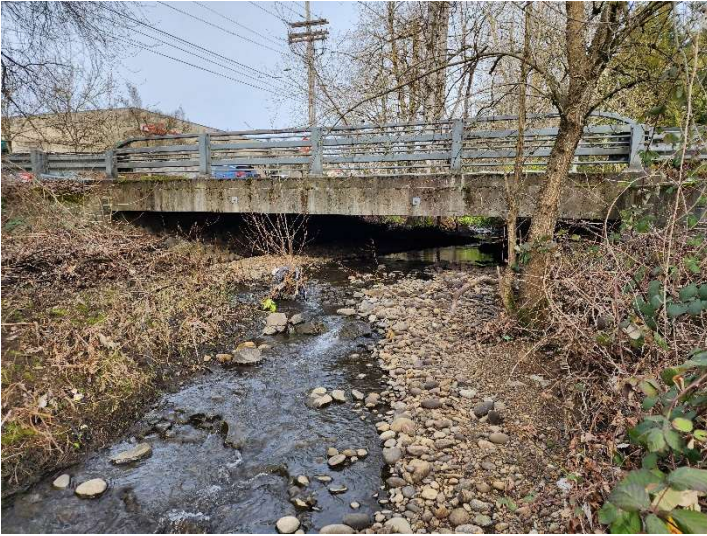
A two lane bridge crossing of Phillips Creek is a secondary access to Costco Wholesale off SE 84th. The bridge abutments are located outside the active stream channel and they do not restrict flows or create any unnatural erosion or sedimentation in the stream channel. The Phillips Creek stream channel is very constricted upstream of this site due to being bound by SE 84th and buildings that are protected by rock gabions. The rock gabions constrict the stream channel to a point that increase water velocity at most stream flows. There is no passage limitation at this crossing but the reach upstream of the crossing is very constricted due to stream bank revetments being present on both sides of the channel that narrow the channel to approximately ½ of the active channel width.

Photo 21. Costco access road bridge over Phillips Creek. Notice high quality of gravel substrate.

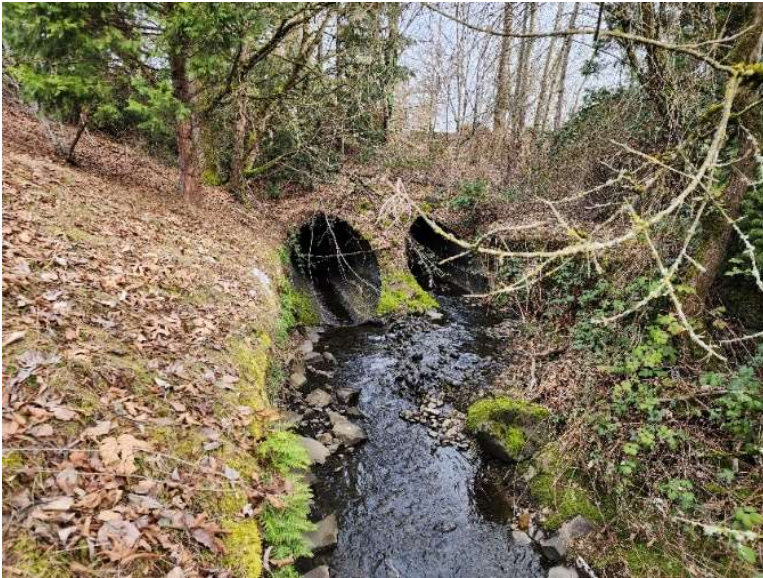
Phillips Creek is conveyed by two CMP's underneath SE Sunnybrook Boulevard. The pipes are set at approximately the same slope as the stream channel which is ~4% in this reach of Phillips Creek. The lack of streambed substrate combined with relatively high slope creates a nearly complete barrier to upstream passage of adult and juvenile fish. It is very unlikely that adult migrating salmonids could effectively pass through the relatively long culvert with high water velocity, lack of water depth and substrate to reduce stream energy and create resting spots for fish.

Photo 22. Two CMP's at relatively high slope and no substrate through entire length. Fill at upstream end of culvert to left forces most flows through the culvert on the right.

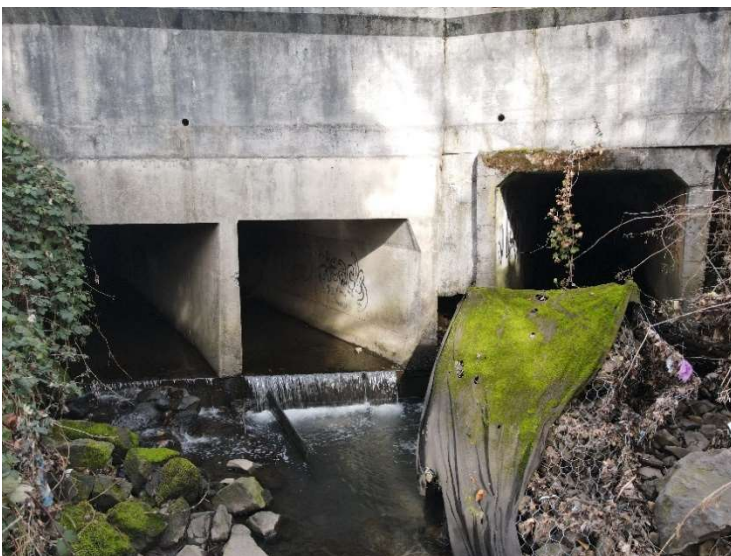
Phillips Creek at SE Sunnyside Boulevard is conveyed through two concrete box culverts. The culvert to the right on the photo below carries water from a stormwater detention pond and is activated during storm events. The concrete box culverts have smooth bottoms and no substrate leading to very low water depth and high water velocity during higher stream flows. There is a 1-foot elevation drop at the downstream end of the culvert creating a challenging jump for smaller resident migratory fish. The smooth concrete bottom that leads to higher velocity flows, overall length of the crossing, and outlet jump create a near complete barrier to upstream passage migratory fish in this reach of Phillips Creek.

Photo 23. Upstream view of the Sunnyside Blvd. crossing of Phillips Creek

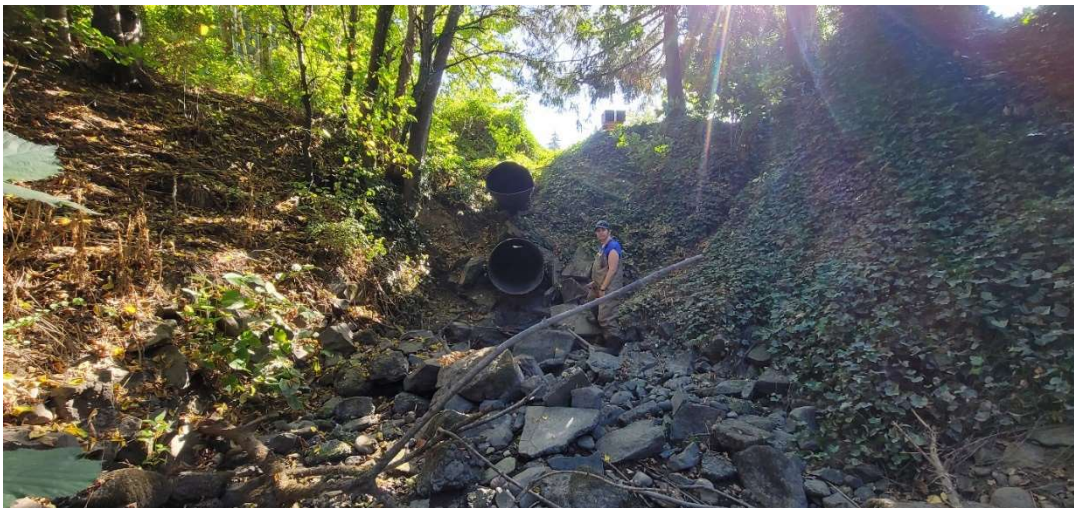
River Forest Creek is conveyed by two CMP's beneath SE River Forest Drive. The culverts impound River Forest Lake and create a complete barrier to upstream passage of migratory fish into River Forest Creek watershed upstream of the lake. Water temperature monitoring indicates the potential for cold water refugia upstream of River Forest Lake. A combination of barrier removal and potential isolation of the River Forest Creek stream channel from the lake could combine to create unrestricted access into the watershed where cold water refugia exists. Other potential barriers upstream of the lake including SE Fair Oaks and SE Laurie should be assessed to determine the extent to which they may restrict passage.

Photo 24. Upstream view of two CMP's near the confluence of River Forest Creek and the Willamette River. Small diameter of culvert and elevation drop >2-feet combine to create complete barrier to upstream passage of migratory fish, including juvenile fish seeking refuge from high temperatures in the Willamette River.

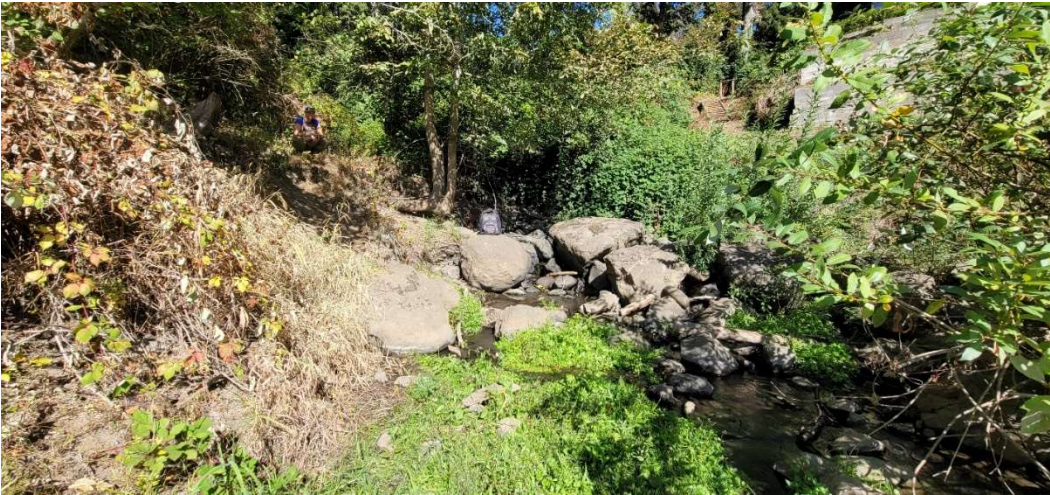
Large boulders located at the confluence of Boardman Creek and the Willamette River create a partial barrier to upstream passage into the Boardman Creek watershed. Juvenile fish are likely restricted during summer months due to a relatively high elevation drop over the boulders. Higher flows in the Willamette River during late fall and winter months reduces the overall drop and on occasion (flood flows) will completely backwater over the top of the boulders leading to no elevation drop or jump for migratory fish. Unfortunately, two partial passage barriers upstream of the boulders restrict access to the upper reaches of Boardman Creek. One partial barrier is a bedrock chute that creates high water velocity and low water depth and another elevation drop approximately 200-feet upstream where a sewage conveyance structure situated in the middle of the Boardman Creek channel. The structure combined with large angular boulders create a substantial challenge for fish migrating upstream as there are several drops between the large boulders.

Photo 25. Large boulders create an elevation drop of >3-feet in lower Boardman Creek. Bedrock chute and instream sewer line infrastructure create additional passage challenges for fish migrating upstream into the Boardman Creek watershed.

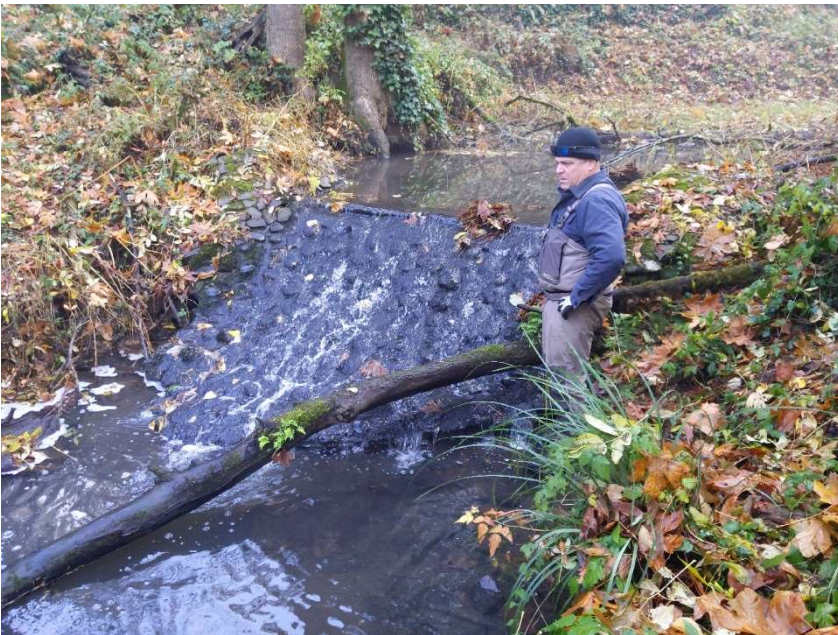
A small dam constructed of small cobble and concrete is present at the upstream end of the beaver pond/wetland complex near the mouth of Rinearson Creek. The dam creates a 3-foot vertical drop in the stream channel and likely restricts access for migratory fish to approximately 200-feet of moderate quality stream habitat before a bedrock cascade completely restricts access to the remainder of the Rinearson Creek watershed.

Photo 26. Cobble dam in lower Rinearson Creek creates a barrier that restricts access to ~200-feet of stream.

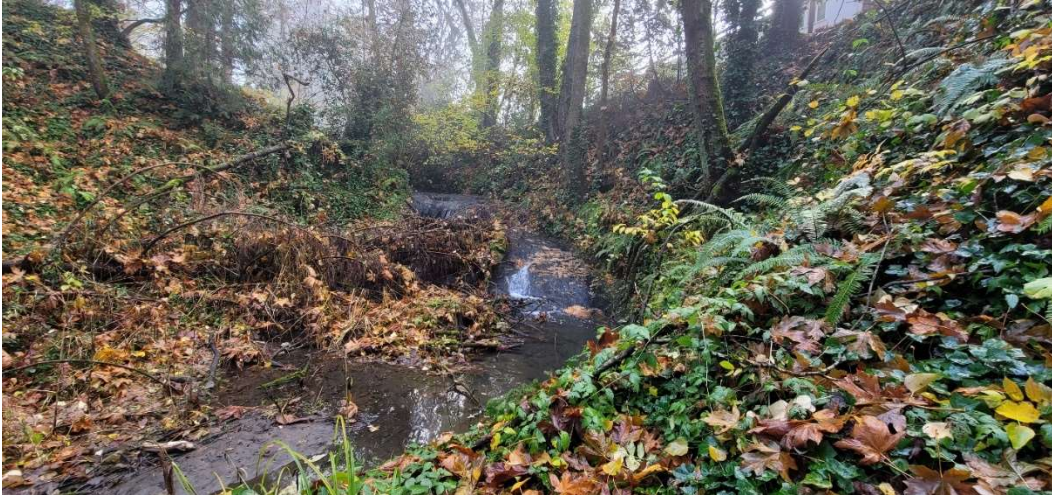
A bedrock cascade in lower Rinearson Creek completely restricts upstream passage of migratory fish in the watershed. The cascade is approximately 300 feet upstream of an existing wetland complex that reaches to the Willamette confluence. A juvenile coho salmon was documented in this reach during survey of the cascade. The slope of the cascade exceeds 30% for over 30-feet of stream length restricting access to all life stages of migratory fish.

Photo 27. *Bedrock cascade in lower Boardman Creek that is a complete barrier to upstream passage.*
