# North Clackamas Watersheds Temperature Study

*January 2023*

Prepared by Amy van Riessen, NCWC Watershed Restoration Manager  
[amy@ncwatersheds.org](mailto:amy@ncwatersheds.org)

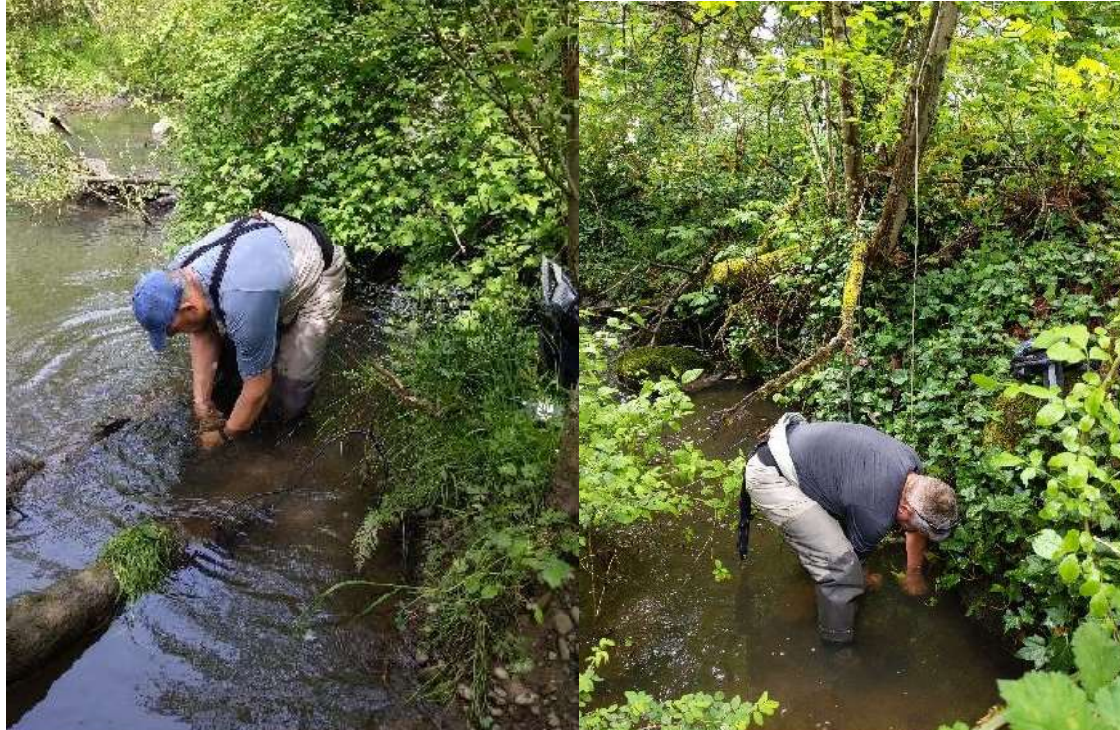
*Figure 2 - Consultant securing ABS pipes containing the temperature probes to underwater rebar.*

At all sites except for Kellogg Dam (Site 1a and 1b), a three-foot piece of rebar was driven into the streambed and was used to secure each thermograph. This rebar was driven to a depth below the surface of the water level, keeping the installation relatively hidden (see Figure 2). At locations that

were accessible to the public, the rebar was topped with a plastic cap to prevent people from injuring themselves on it. The probes were housed in a 2" ABS pipe that had 15-20 ¼ inch holes drilled out to allow water to through on a constant basis while preventing potential sediment accumulation around the probe. Stainless steel cable and clamps then attached the ABS pipe to the rebar to ensure probes were not lost during the sampling period. Once the rebar and pipe were installed, the probe was not noticeable from above the water to prevent tampering. For this reason, photos were taken at every installation location and the sample sites were geo-located utilizing the ArcGIS Field Maps phone app to ensure that the rebar could be found when collecting the probes at the end of the sample season.

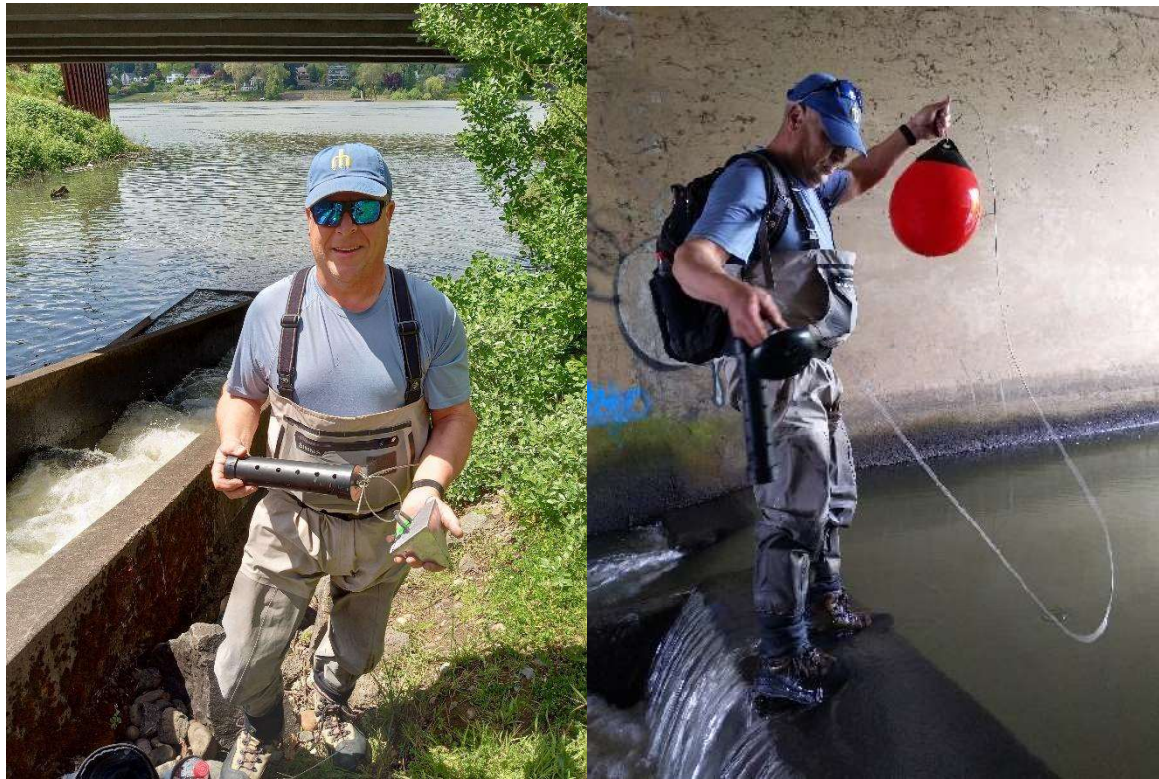
*Figure 3 - Two different methods were used to install loggers at Kellogg Dam. In the fish ladder (left photo) the unit was submerged using a 10-pound weight. In the impoundment (right photo), the logger was attached to an anchor that was marked with a buoy.*

Two temperature loggers were installed at the mouth of Kellogg Creek, one in the fish ladder (Site 1a) and one in the impoundment just upstream of the dam (Site 1b). The thermograph in the fish ladder was put in a ABS pipe and affixed to a 10-pound weight, and then sunk into the fish ladder. The logger in the impoundment was attached to an anchor that was sunk in the lake, which was all attached to a buoy for retrieval (see Figure 3). The reason for launching two loggers at this site is that staff from ODOT mentioned they have had several temperature loggers stolen from this area, due to the high use and visibility by the public. The logger in the impoundment that was attached to the buoy did indeed get stolen. Thankfully the probe in the fish ladder was recovered.

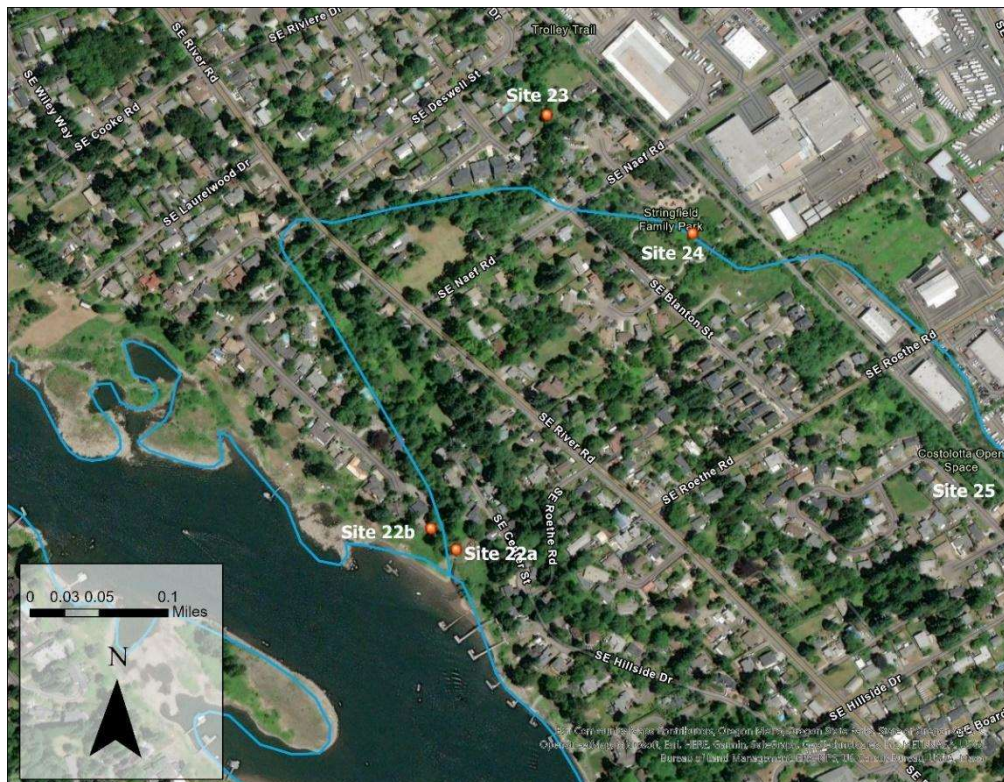
*Figure 12 - Location of Boardman Creek confluence temperature loggers.*

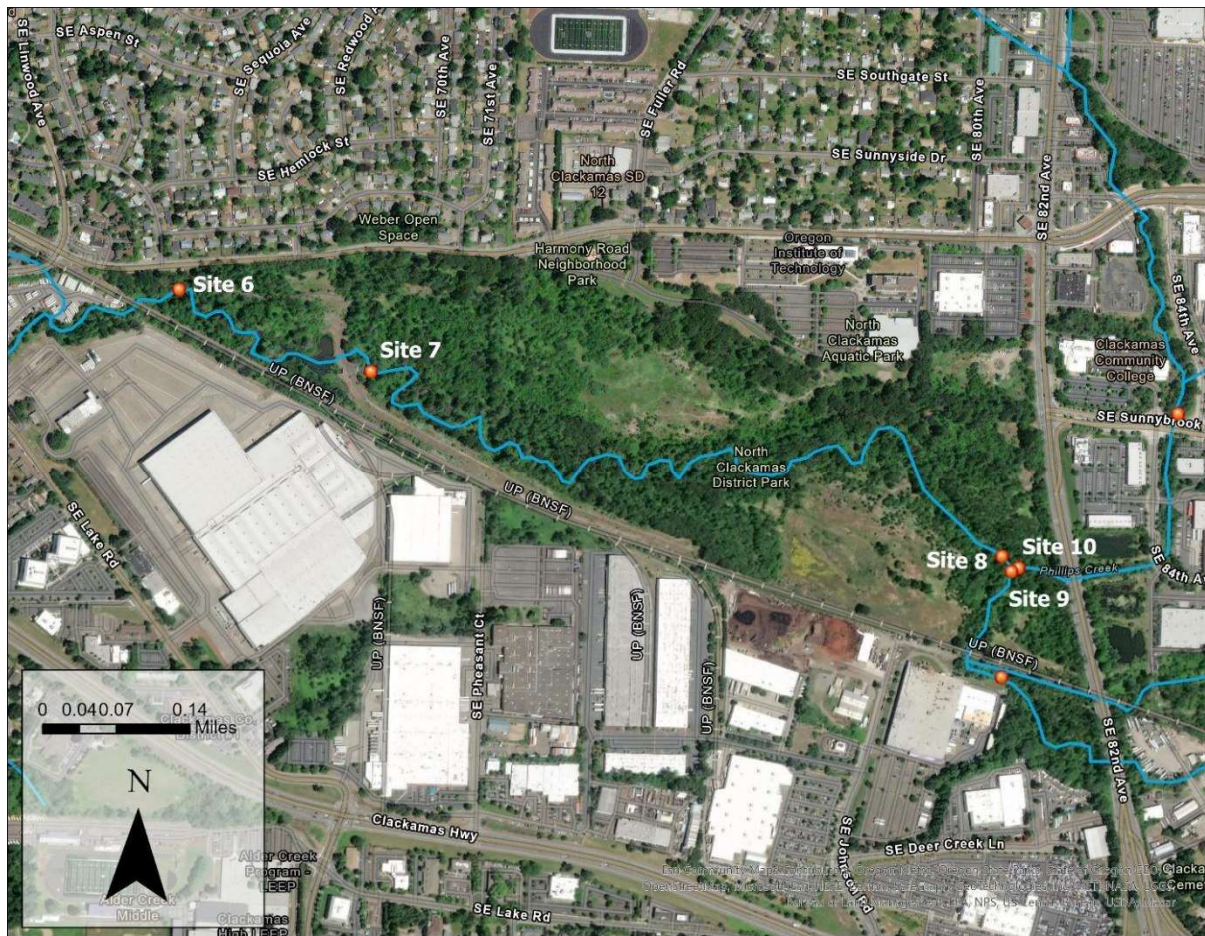
Figure 20 - Location of 3-Creeks Natural Area temperature loggers.

The 3-Creeks Natural Area is approximately 89 acres of streams, wetlands, and upland habitat that encompasses Mt. Scott Creek and its confluences with Phillips and Dean Creeks. The site is wedged in between industrial and commercial properties, a set of active railroad tracks, and private homes. The site is also owned by Clackamas Water Environment Services (WES) and is home to a flood control facility which stores water during the heaviest rains to protect businesses and infrastructure. There were five thermographs installed throughout 3-Creeks Natural Area. The temperature study of the confluences of Phillips Creek and Dean Creek with Mt. Scott Creek is discussed in the previous section, and shows how those two tributaries contributed colder water to the Mt. Scott mainstem.

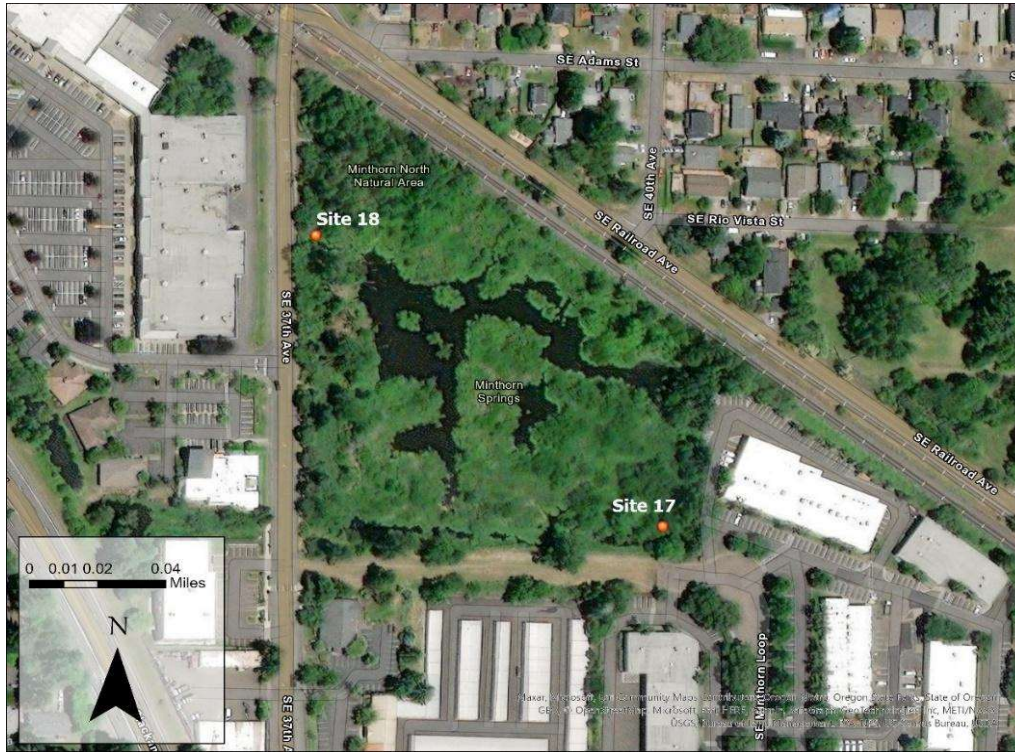
Figure 22 - Location of Minthorn Springs temperature loggers.

The Wetlands Conservancy Urban Wetlands State-of-the-Catchments Summary (Labbe and Scully-Engelmeyer, 2016) noted that the water quality in Minthorn Springs Wetland is considered poor. For this investigation, we assessed the difference between water temperatures coming directly out of the spring seep at the inlet of the wetland (Site 18), versus water temperatures exiting the wetlands into Minthorn Creek (Site 17). The location of the two temperature loggers can be seen below.

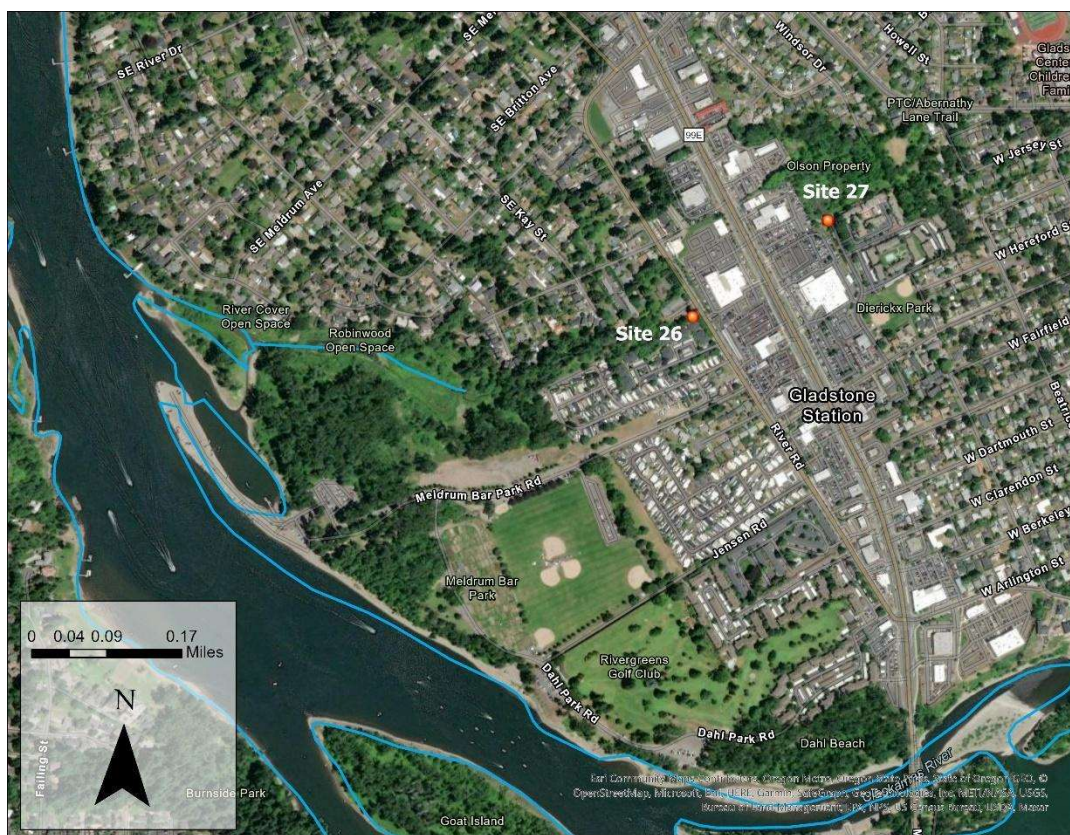
Figure 26 - Location of Rinearson Creek temperature loggers.

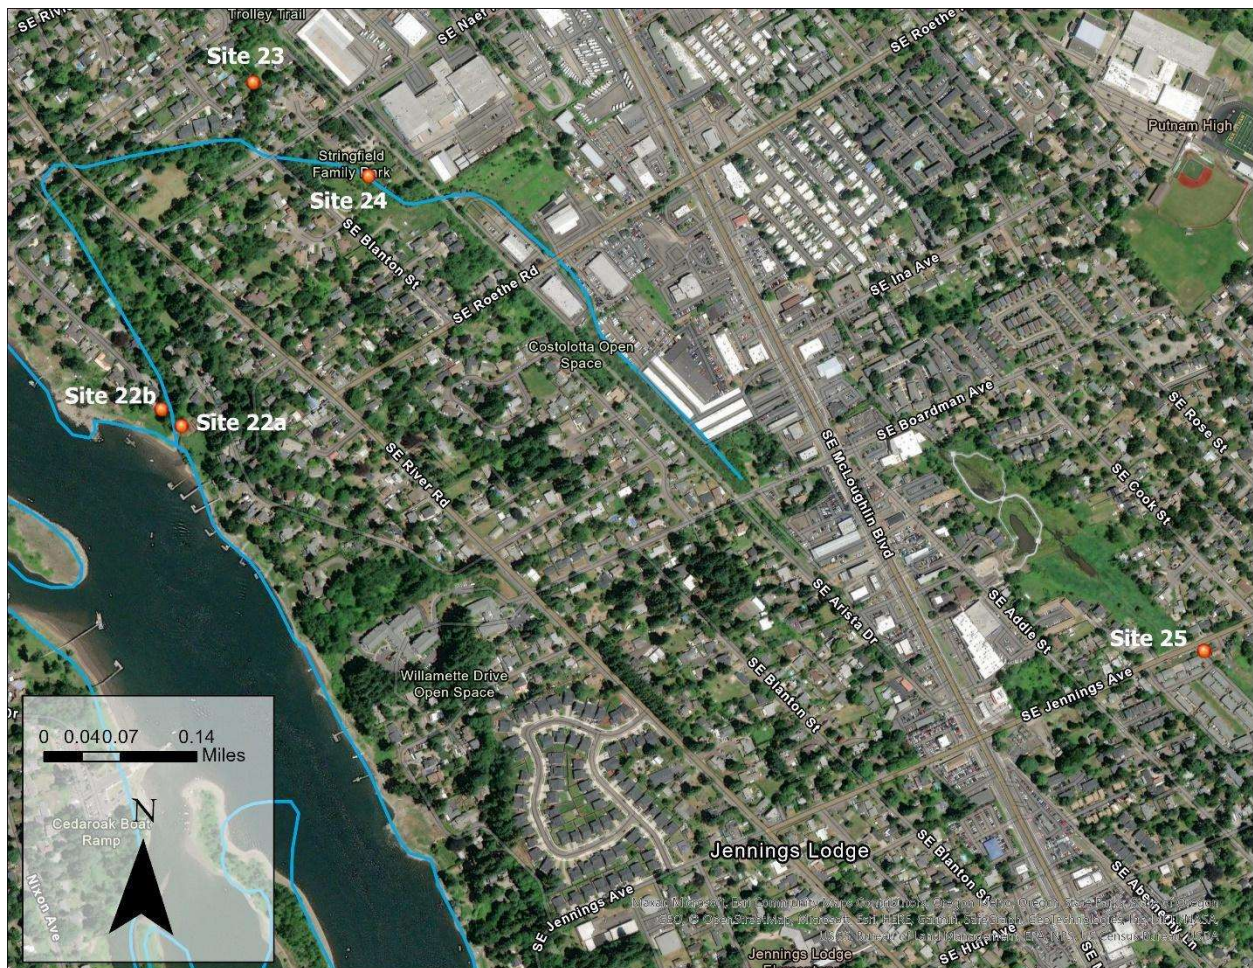
Figure 28 - Location of Boardman Creek temperature loggers.
